INANGAHUA EARTHQUAKE 1968

DAMAGE TO STATE HIGHWAYS

J. S. Douglas, A.M.I.C.E.*

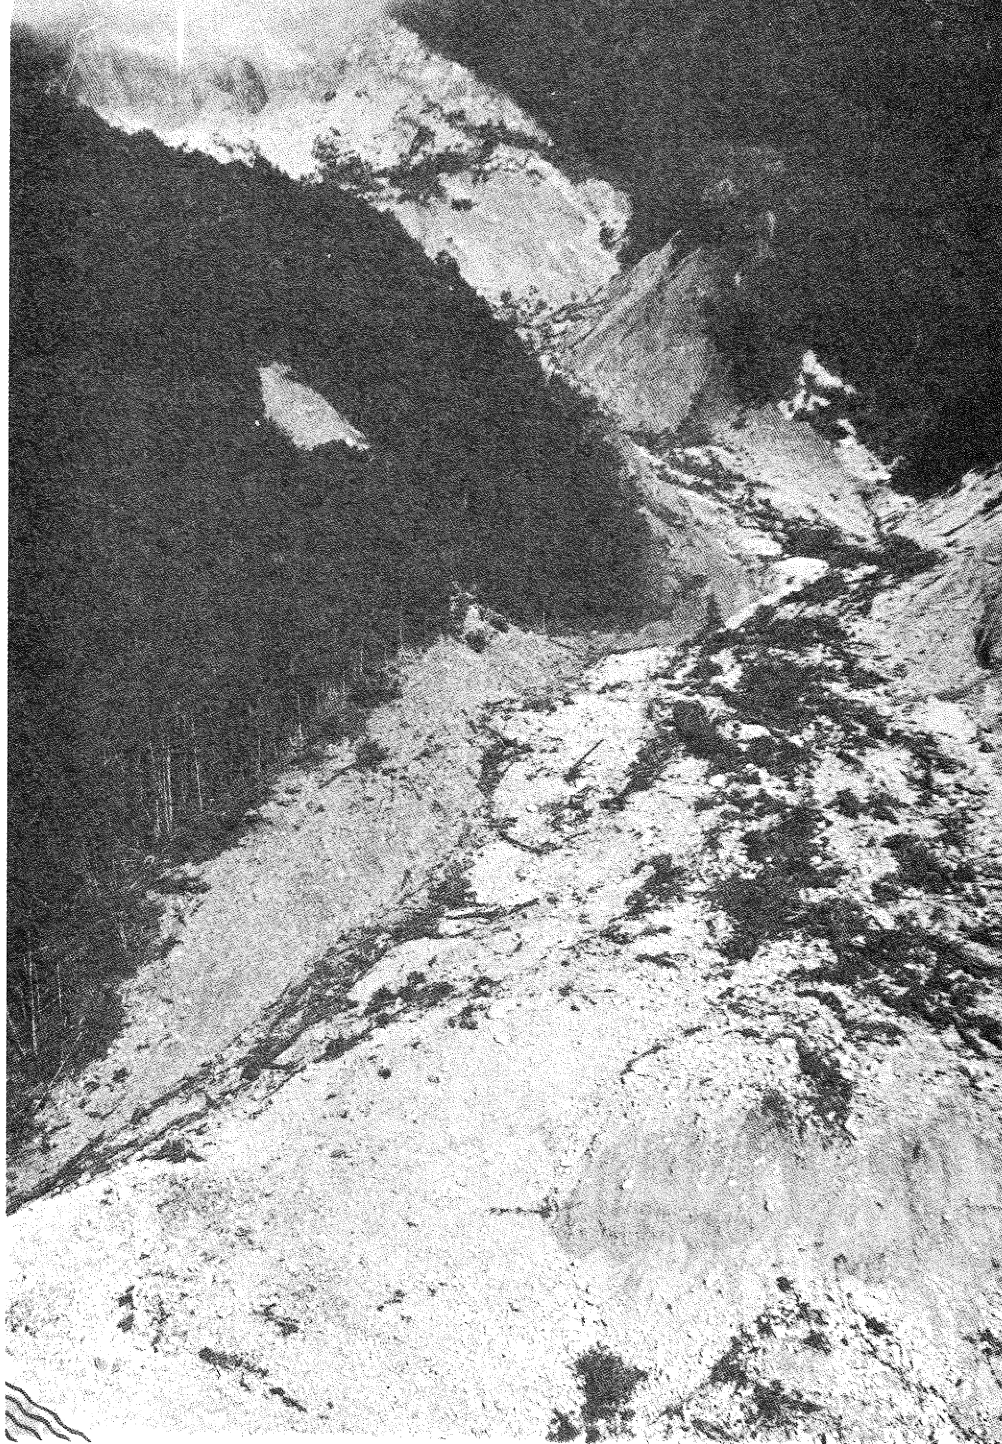
S.H.G R.M. 173.00^M

Avalanche opposite Dublin Terrace.
- Dammed Buller River

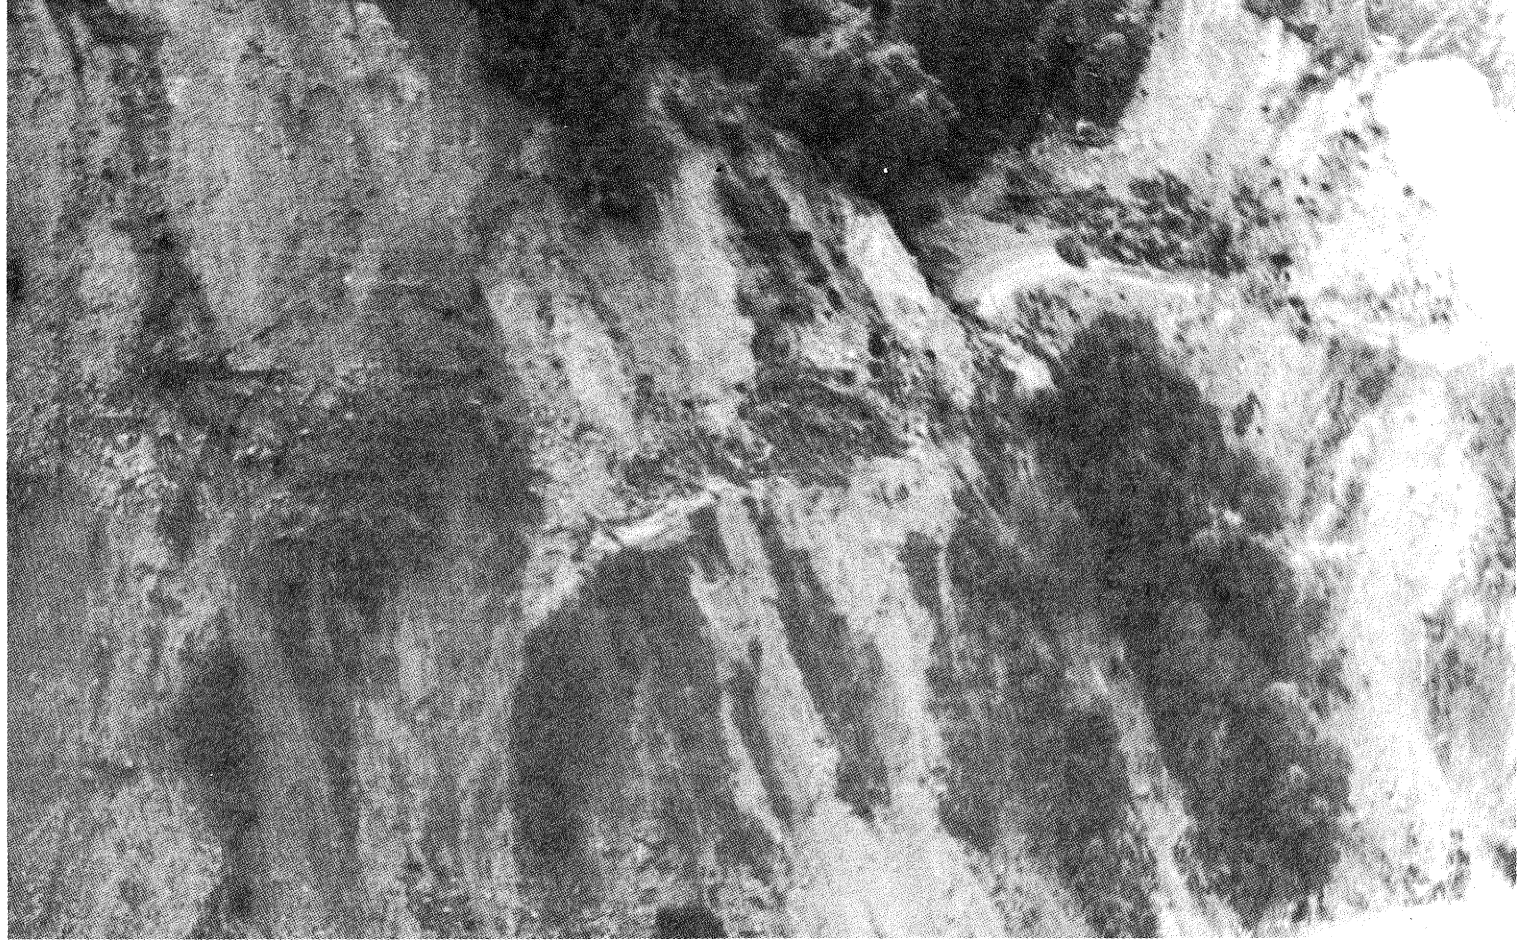
S.H.G R.M. 175.00 M.

Typical slips : Eight Mile Ck. - Lyell Ck. Section

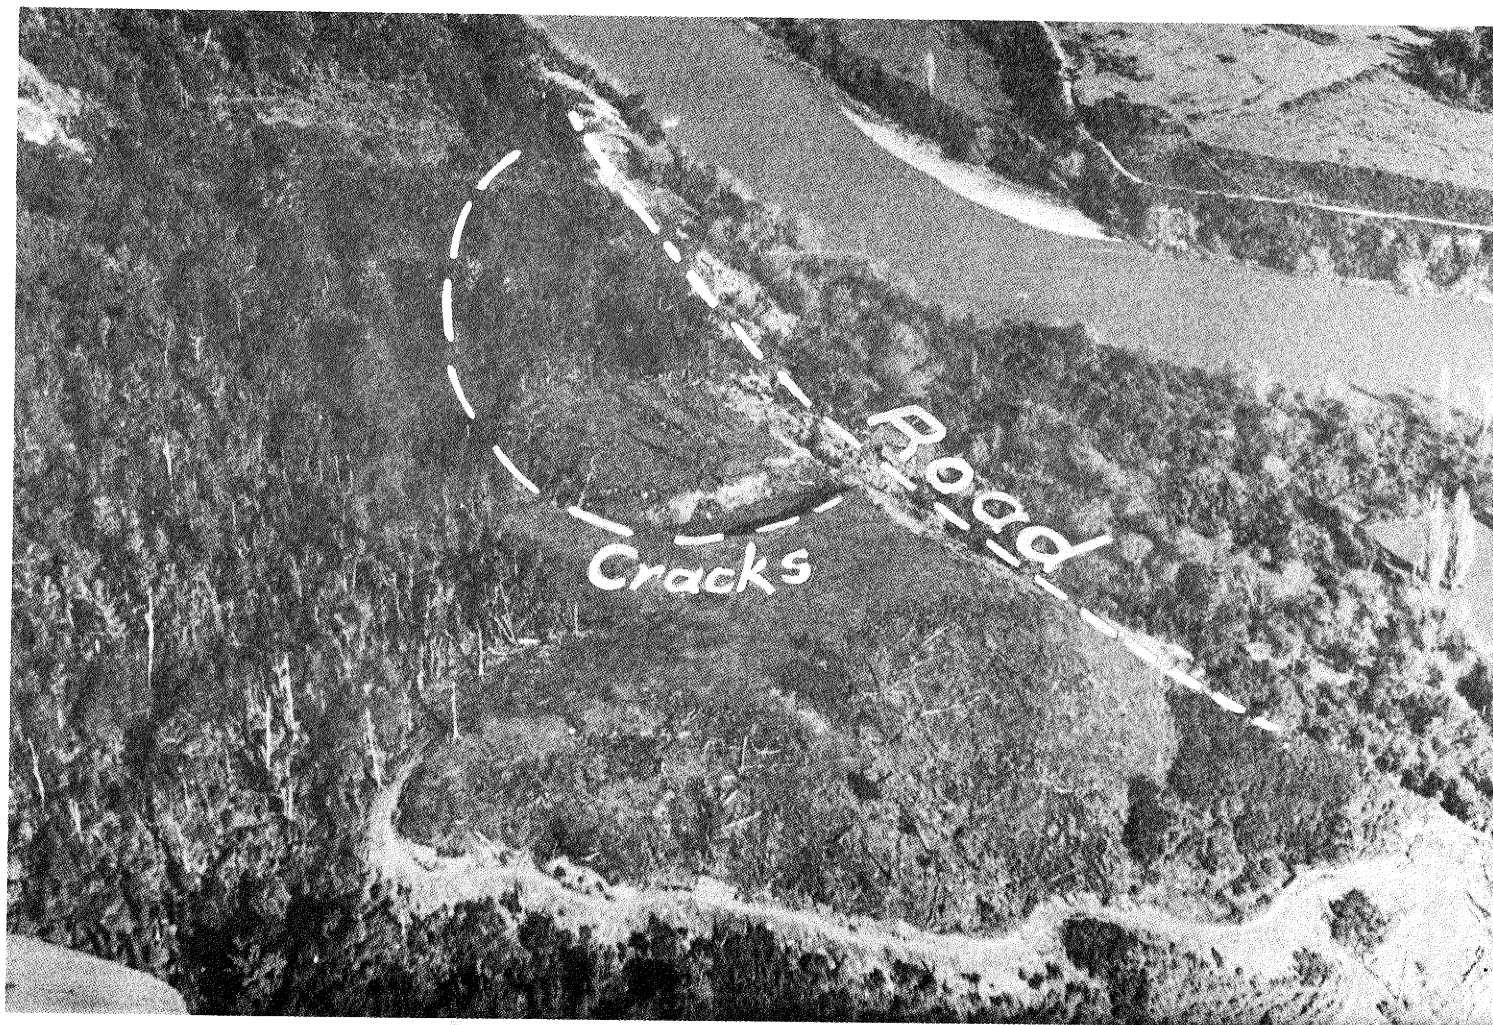
S.H.G. R.M. 178.80^m

Slip at Van Vugh's showing cracks in terrain

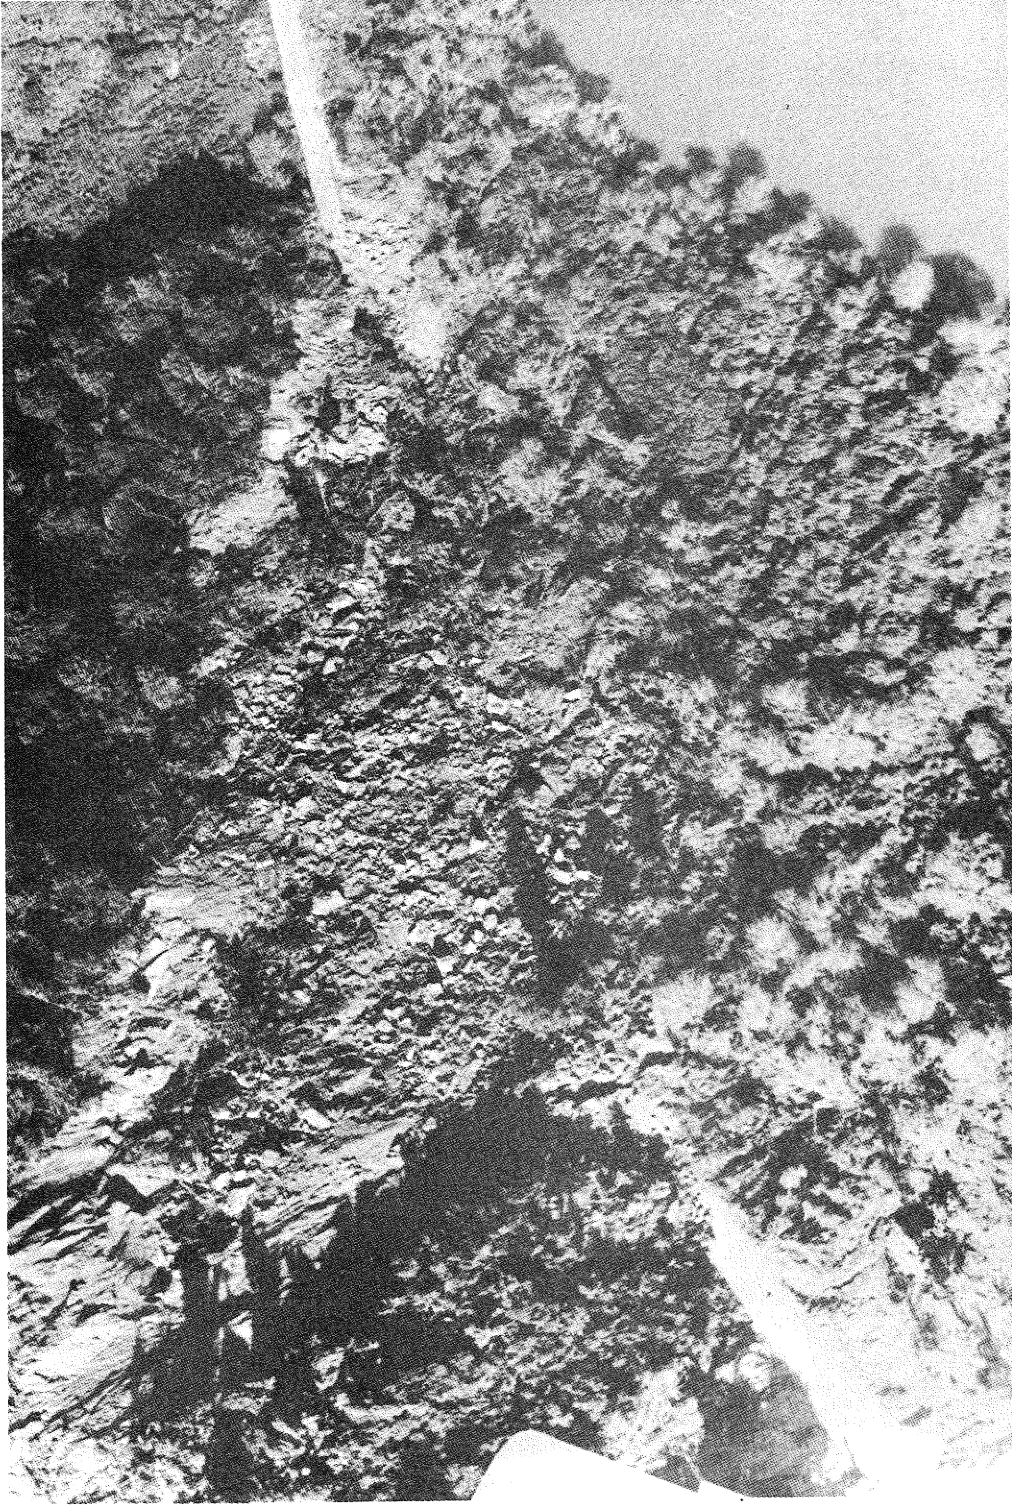
S.H.G. R.M. 178·80M
Rotational slide in papa near Van Vughs

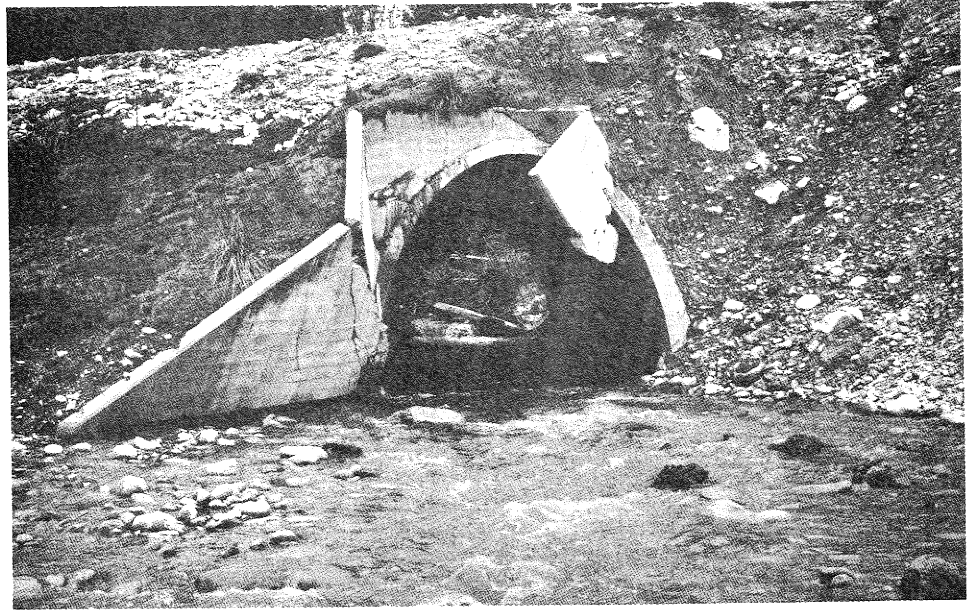
*S.H.G R.M. 182.55
De Filippi Culvert damage*

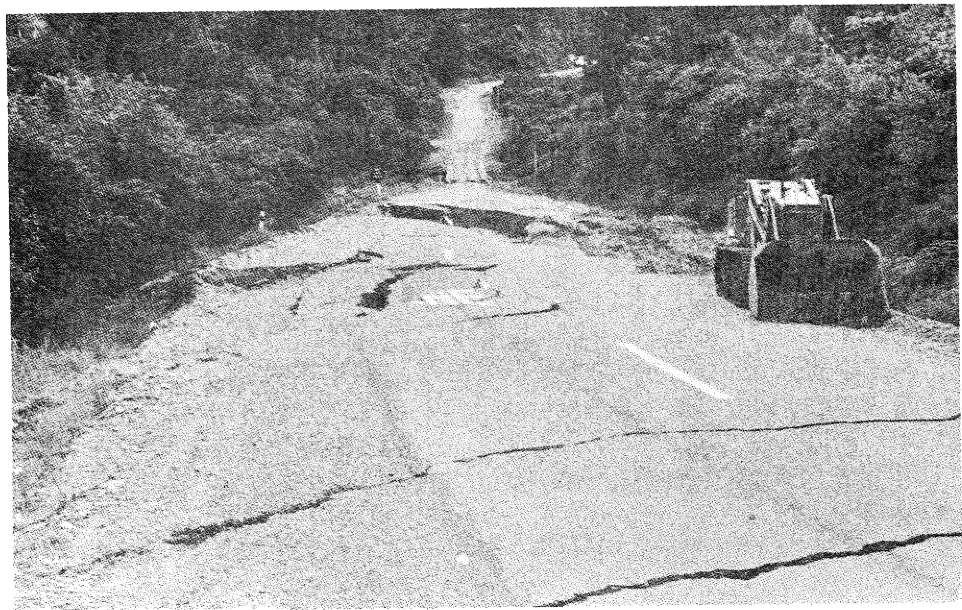
*S.H.G R.M. 193.80^M.
Coal Creek approaches : Road subsidence*

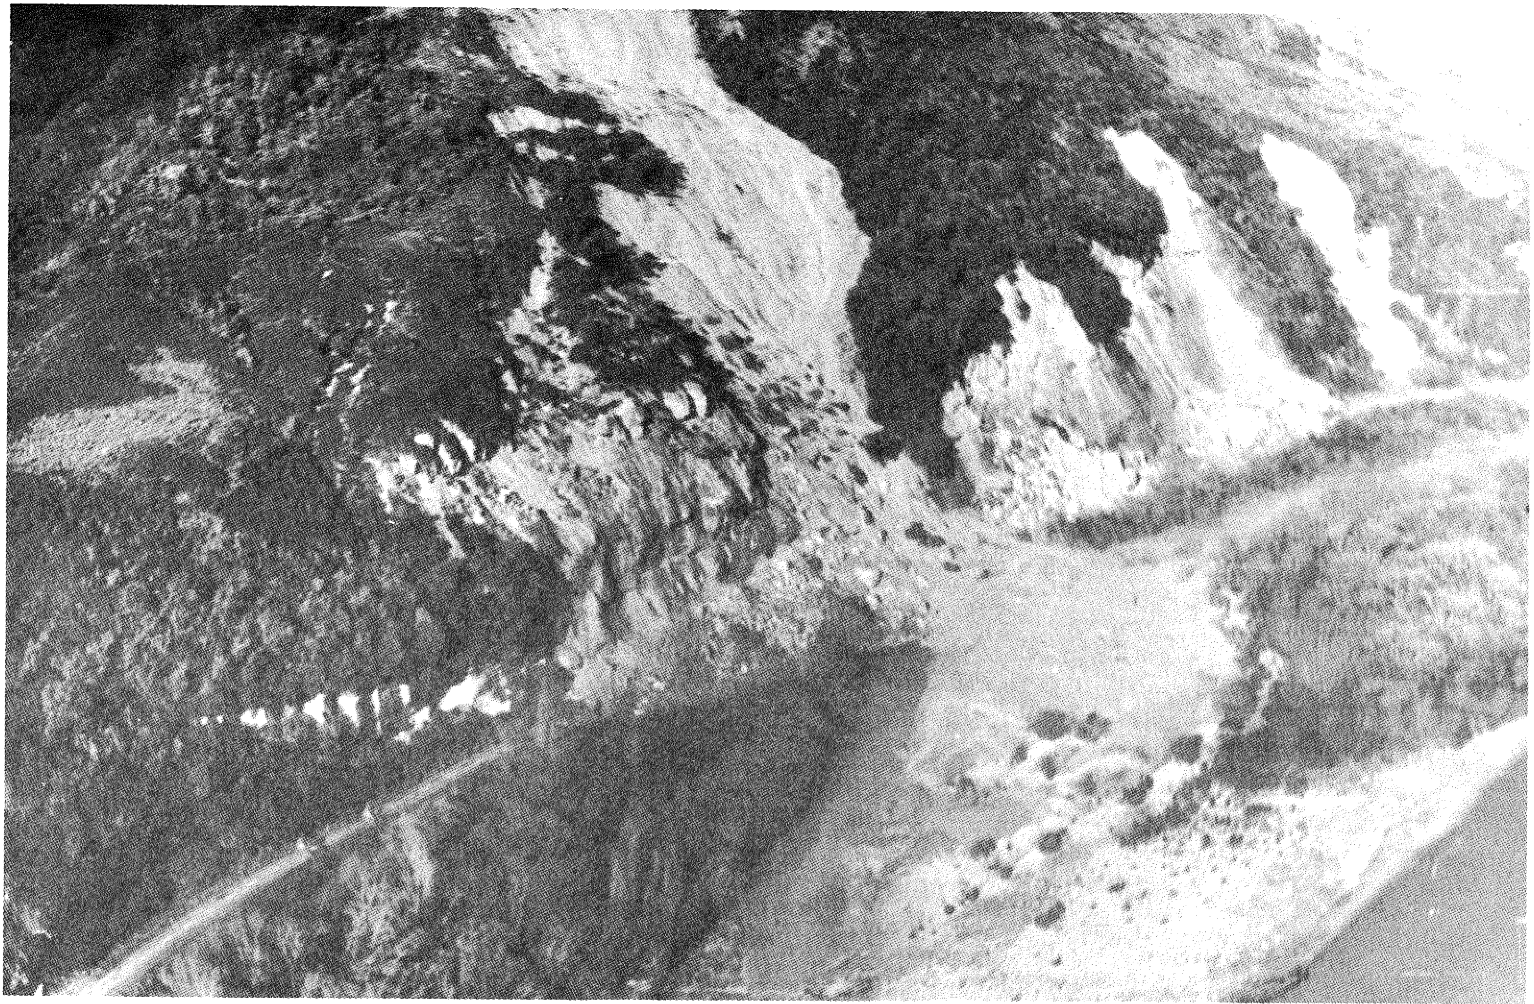
S.H.G. R.M. 190.00 M.

Rockfalls and landslides at Whitecliffs.

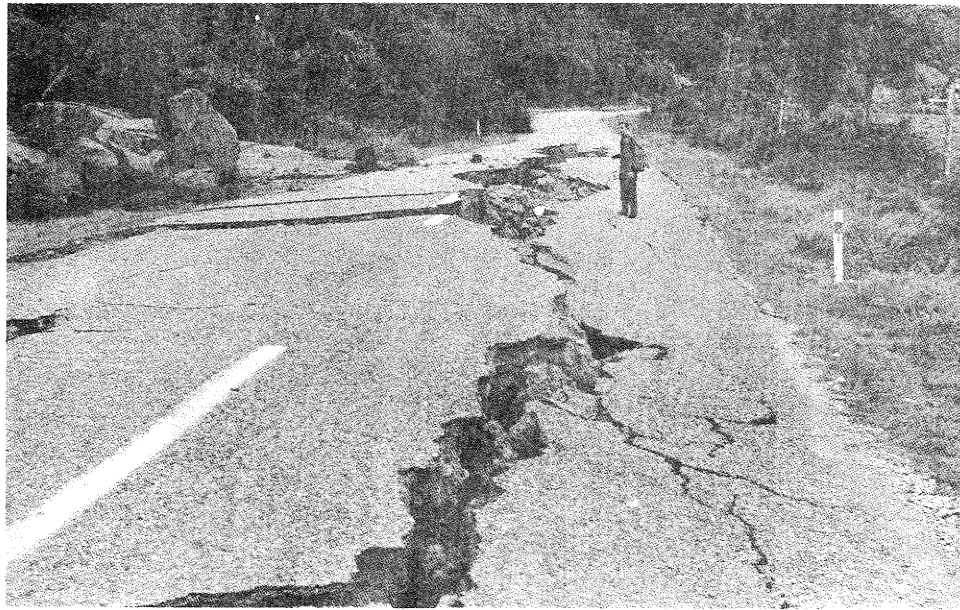
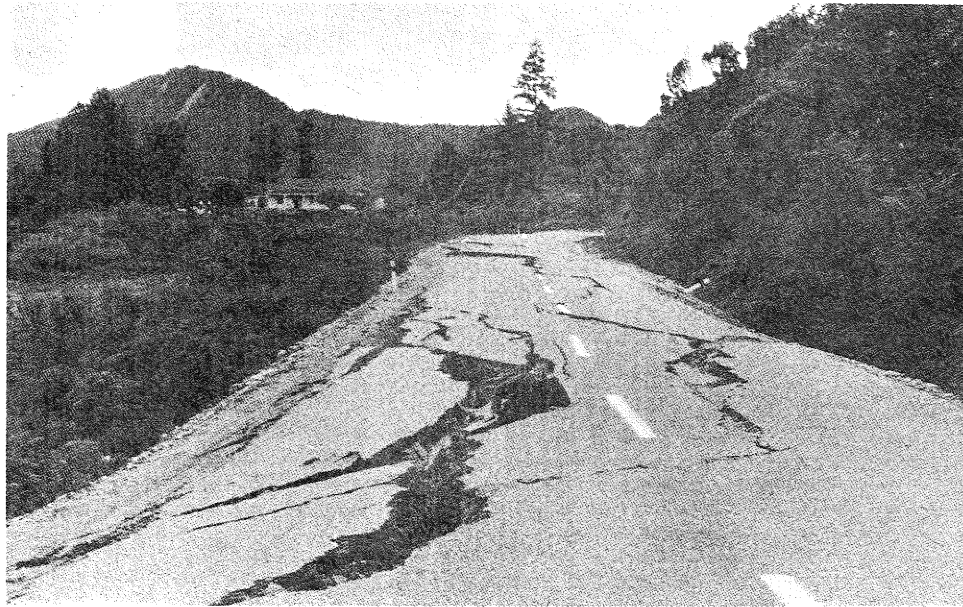
S.H.G R.M. 192.00^M.

Typical highway damage at Rocklands.

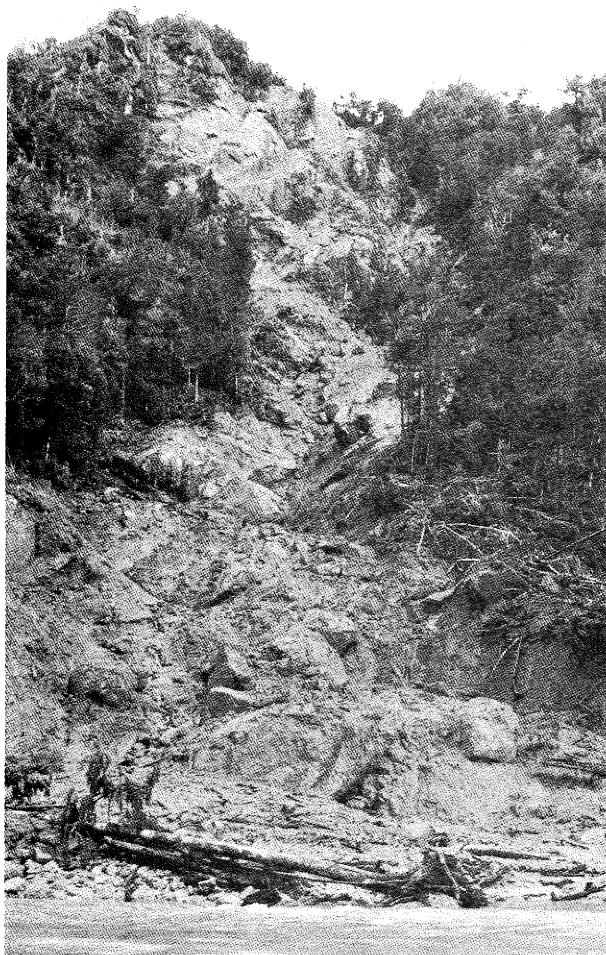
S.H.G R.M. 196-90^m.

Rock and clay slip at Stitt's Bluff.
