PERFORMANCE OF UNREINFORCED AND RETROFITTED MASONRY BUILDINGS DURING THE 2010 DARFIELD EARTHQUAKE

Dmytro Dizhur, Najif Ismail, Charlotte Knox, Ronald Lumantarna and Jason M. Ingham

SUMMARY

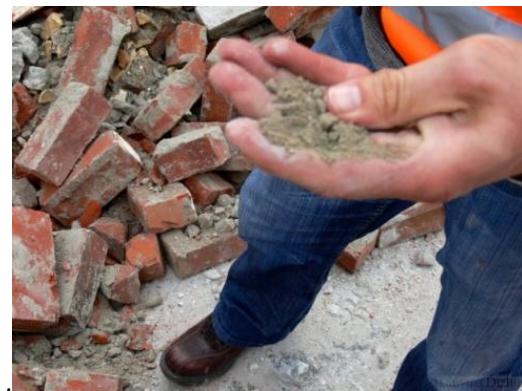
The debris from collapsed URM walls revealed that the mortar in the walls that failed during the earthquake was of poor quality, while the brick units remained in good condition. The particles in the poor quality mortars had almost zero cohesion and interlocking, and therefore these mortars often crumbled under finger compression (see Figure 6). The brick-mortar bond was almost non-existent for these poor quality mortars, as most brick units from the fallen masonry debris were separated from each other instead of remaining as larger masonry segments [29].

Figure 6: Example of weak mortar from damaged building.

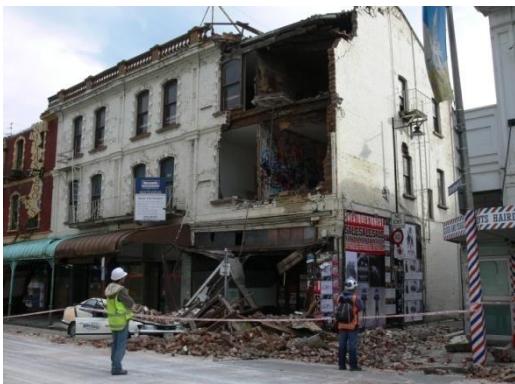
The building sustained considerable damage, mainly concentrated at the end bay (139 Manchester Street) where the front facade entirely collapsed out-of-plane (refer to Figure 9). The entire building sustained damage from collapsed parapets, apart from two bays (135 and 137 Manchester Street) where the parapets remained on the building as illustrated in Figure 9. From visual observations and physical assessment of the collapsed masonry the mortar was found to be in a moist condition and the mortar that was adhered to the bricks readily crumbled when subjected to finger pressure (see Figure 6), suggesting that the mortar compression strength was low ($< 2 \text{ MPa}$). The collapsed facade wall revealed extensive water damage to the timber structure, with rotten floor joists and roof rafters. Also, it was observed that there were large patches of moist masonry on the interior surface of the building, especially around the roof area (there was no precipitation during the period following the earthquake and prior to building inspection).

Figure 9: 135-139 Manchester Street, out-of-plane facade collapse.

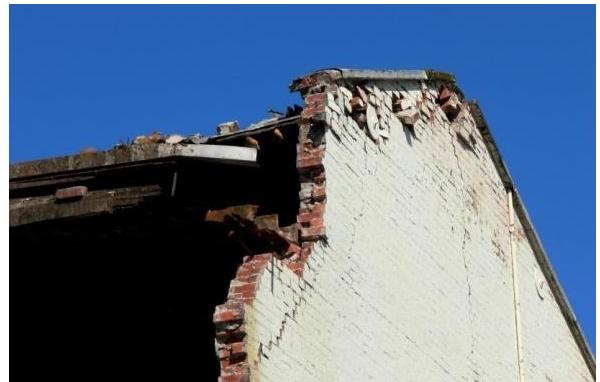
It appears that the through steel anchors at the gable did not provide sufficient restraint to the masonry, with the brickwork being pulled around the steel anchor plates (refer to Figure 10). Furthermore, from images prior to the earthquake it is evident that there were significant cracks through the spandrel and the parapet over the top corner window of 139 Manchester Street. Falling parapets landed on the canopies, resulting in an overloading of the supporting tension braces that led to canopy collapse. The connections appeared to consist of a long, roughly 25 mm diameter rod, with a rectangular steel plate (approximately 5 mm thick) at the wall end that was approximately 50 mm wide x 450 mm long and fastened to the rod, and was anchored either on the interior surface or within the centre of the masonry pier or wall. The force on the rod exceeded the capacity of the masonry, causing a punching shear failure in the masonry wall (refer to Figure 11).

Figure 10: 139 Manchester Street, through steel anchors and rotten timber roof diaphragm.

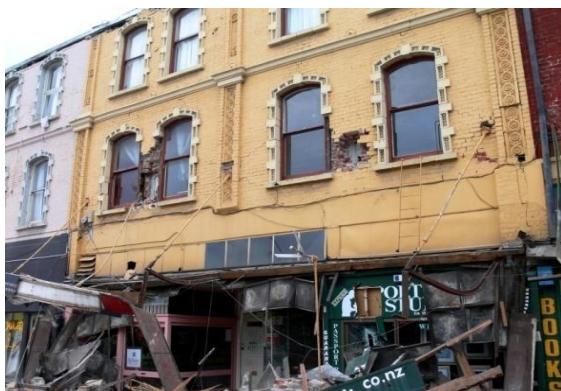
Figure 11: 137 Manchester Street, pull out of the canopy supports.

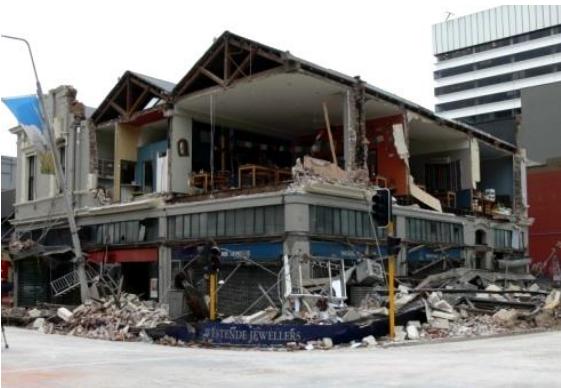
The building experienced a complete out-of-plane collapse of the street front corner facade walls (refer to Figure 13). Anchors in the gables did not provide sufficient restraint, as they remained in the timber roof structure following the earthquake as shown in Figure 14. Steel anchor plates which were observed along the Worcester Street roof were positioned between the masonry leafs. These anchors remained in the timber roof structure, indicating that insufficient out-of-plane restraint was provided. Due to excessive damage and safety considerations the building was subsequently demolished.

Figure 13: Welstead House, 184-188 Manchester Street, after the earthquake.

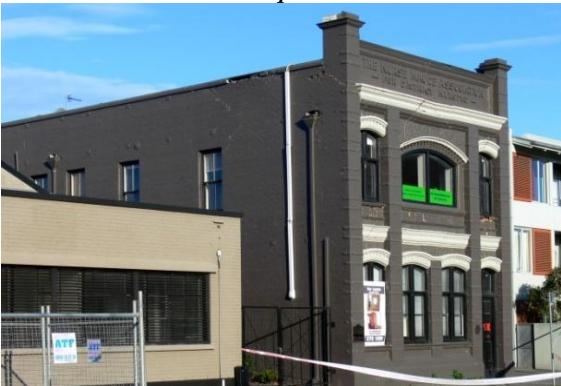
Comprehensive damage was visible to the facade wall, with the spandrel panels at the first floor and roof level having extensive cracking, both vertically and diagonally. There appeared to be some movement of the facade at the diaphragm level in the horizontal direction perpendicular to the plane of the wall. The side walls suffered diagonal shear failures that were visible internally, extending into the stairway wells [41]. The parapet remained attached, as it is supported to some extent by masonry columns that are an extension of the side walls. A diagonal crack extended from the intersection between the top east corner of the side wall and the masonry column diagonally down (seen in Figure 15 and 16), indicating possible rocking of the parapet block out-of-plane.

Figure 15: 192 Madras Street, cracking through top spandrel.

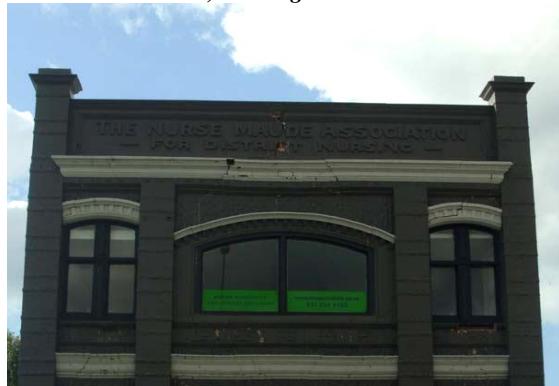
Figure 16: 192 Madras Street, in-plane diagonal cracking through top spandrel.

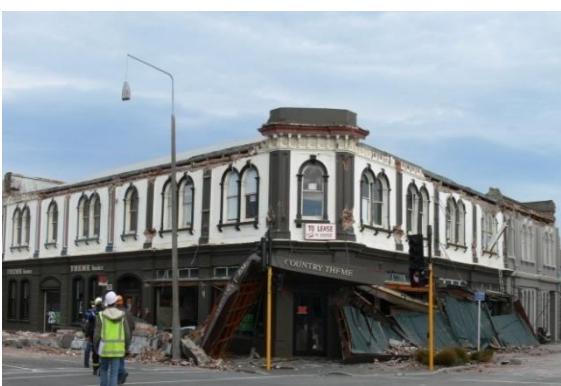
The most apparent earthquake damage was the toppled parapets around the street frontage as illustrated in Figure 17 and 18, with a lightly reinforced concrete beam on top of the parapet providing insufficient restraint. Falling parapets landed on the canopies below, resulting in an overloading of the supporting tension braces that led to a punching shear failure in the masonry wall and resulted in canopy collapse. The connections appeared to consist of a long, roughly 25 mm diameter rod, with a round steel plate (about 10 mm thick) at the wall end that was approximately 150 mm in diameter.

Figure 17: Cecil House / Country Theme Building, 68-76 Manchester Street, parapet collapse.

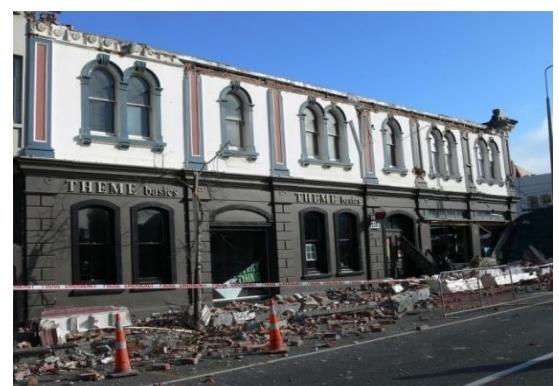
Figure 18: Cecil House / Country Theme Building, 68-76 Manchester Street, concrete beam on the ground.

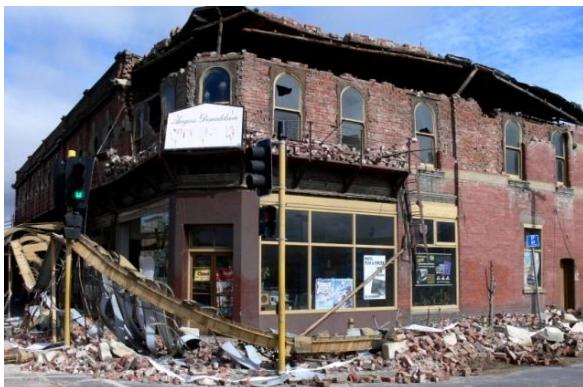
The majority of the observed damage was concentrated along Sandyford Street (end two bays) where complete collapse of the parapets, the wall section in the roof space and delimitation of the external veneer were the main damage that was observed (refer to Figure 19 and 20).

Figure 19: 463-469 Colombo Street, collapse of the veneer.

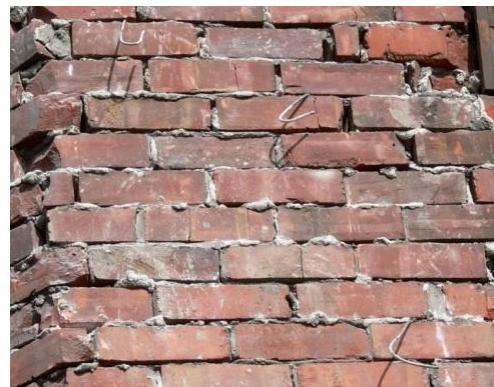
The collapsed external veneer layer revealed that the wire veneer ties were generally in good condition, with a few ties being affected by rust. It was also observed that most of the ties remained in the internal layer as illustrated in Figure 21 and 22, and that the internal surface of the cavity wall was constructed to a poorer quality in comparison to the external layer, indicated by a large number of visible voids and broken bricks used. It is believed that the pocketed ceiling rafters provided sufficient support to the internal leaf of the cavity wall, preventing out-of-plane collapse. It was also observed that some of the roof structure members in the vicinity of the drainage gutters were in a poor condition.

Figure 20: 463-469 Colombo Street, exposed wire veneer ties

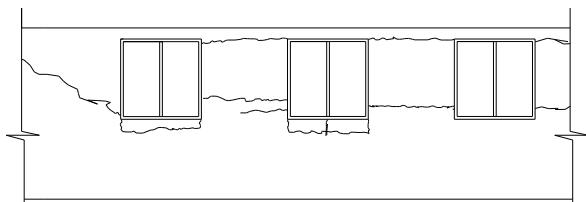
Overall the building performed well, with no significant damage, and was tagged green during initial inspection. Minor cracking was observed at the ceiling level and at the wall-ceiling corners. There was no visible cracking at the location of surface bonded FRP sheets, as shown in Figure 56, although there were visible cracks in the plaster in the external piers along the corridor running east-west in the south part of the building, as shown in Figure 27 (no cracks were detected through the veneer at the same locations). Horizontal cracking and spalling of the plaster layer was observed at the north east wall (see Figure 57). In addition, a minor step-wise crack through the veneer was observed in the south-west corner of the building.

Figure 27: Shirley Community Centre; crack pattern in the plaster layer around the window openings in the external wall of the south corridor

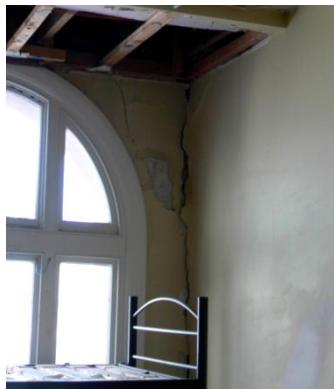
Some minor internal cracks were observed on the side of the building facing Cathedral Square, and large interior cracks at the top of the façade (separation of front facade from the in-plane walls of nearly 100 mm) were attributed to insufficient wall-diaphragm anchorage (refer Figure 38). Damage to the wooden partition interior walls was also observed, which provided evidence that large out-of-plane deformation of the front façade wall occurred. As a post earthquake hazard

Figure 38: 56 Cathedral Square, façade separation.

mitigation measure, the front façade was secured by introducing temporary steel rod anchors and the unstable façade top was tied to the diaphragm at the roof level. Figure 39 shows minor in-plane cracks that were observed in the spandrel of the front facade wall at ground level.

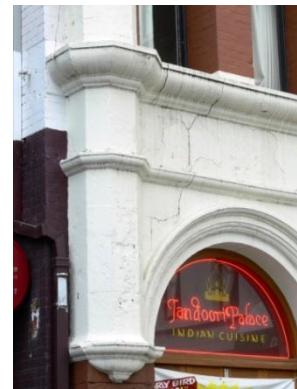
Figure 39: 56 Cathedral Square, cracking through the spandrel on ground level.

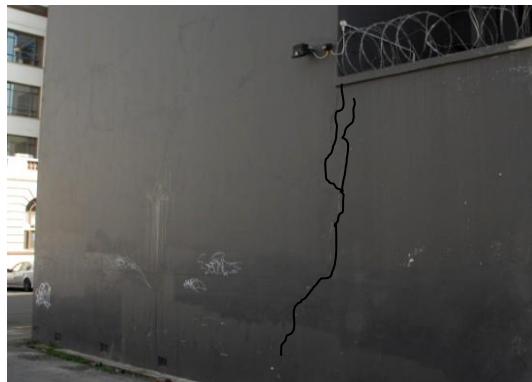
The retrofit increased the stiffness in one direction only, creating differential stiffness between the building's two principal axes which may have accentuated the building's torsional response, resulting in diagonal shear cracks at the rear face of the building as shown in Figure 47. Some localised punching of bricks away from the steel moment frame was also observed and was attributed to the frame pounding against the URM wall at the locations adjacent to the beam-column joint. However, no cracks were visible at the ground floor level. The parapet was cracked at the roof line and had been temporarily strengthened using steel tie backs to the roof (see Figure 48). The occupants stated that the parapet crack appeared in the Wednesday (8th September 2010) M5.0 aftershock [7], and that the displacement amplitude of the building was small with high frequency vibrations. Pounding damage was also observed due to twisting of this building towards the neighbouring building, which exceeded the seismic gap allowance. Damage is shown in Figure 48.

Figure 47: 194 Hereford Street, highlighted crack location at the rear of building.

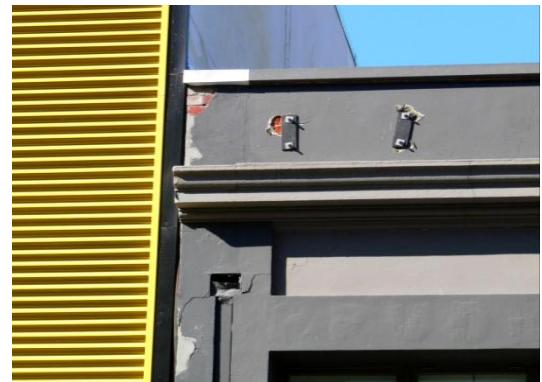
Figure 48: 194 Hereford Street, reduction of seismic gap.

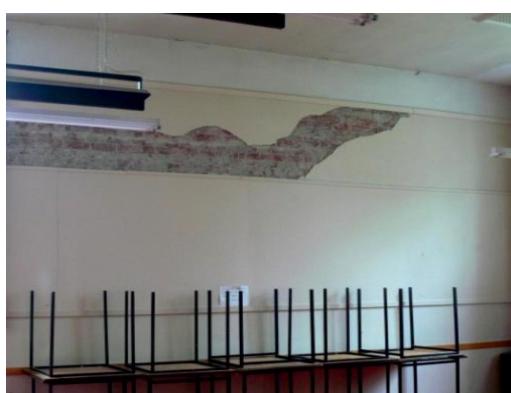
Figure 57: Shirley Community Centre, loss of plaster in north east wall.

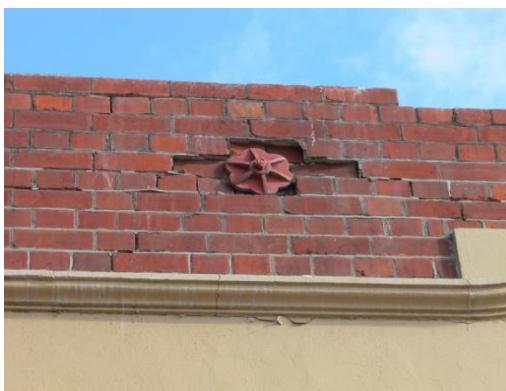
The parapets collapsed out-of-plane and wall-diaphragm anchors pulled out from the wall, with the anchors punching through the brickwork and creating localized wall damage (refer to Figure 60). The building was cordoned off as falling hazards had been identified during post-earthquake evaluation.

Figure 59: 242 Moorhouse Avenue, wall-diaphragm anchor punching.

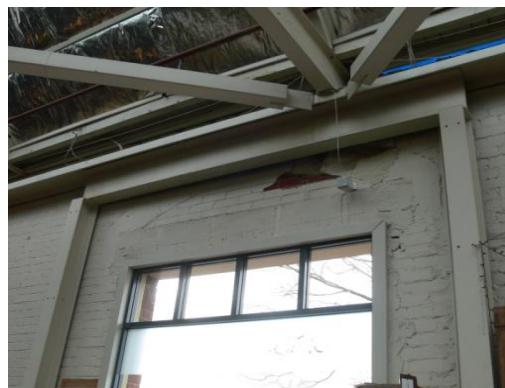
Figure 61: 242 Moorhouse Avenue, interior of the building (location where anchor plate pull out occurred).
