PERFORMANCE OF RESIDENTIAL HOUSES IN THE DARFIELD (CANTERBURY) EARTHQUAKE

Andrew H. Buchanan¹ and Michael P. Newcombe²

This paper focuses on the observed seismic performance of residential houses (mainly single-storey and two-storey houses) in the Darfield earthquake on 4 September 2010 and identifies potential research areas for remediation and resilience.

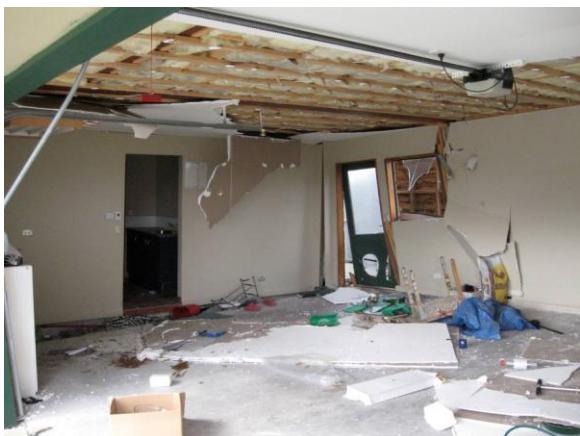
The amount and uniformity of ground settlement varied greatly from site to site. On sites where the settlement was mainly uniform the structural integrity of the house foundations remained essentially intact but some buildings tilted, causing minor structural damage. On sites where differential settlement or lateral spreading occurred, the buildings became distorted, resulting in cracks in concrete slabs and foundations, brick veneers, and internal linings. On sites where severe lateral spreading occurred, such as Courtenay Drive in Kaiapoi, buildings suffered from extensive structural damage (see Figure 1). Sinking into soft soils appeared to be more severe for buildings with heavy brick cladding and heavy tile roofs.

Figure 1: Lateral spreading of house in Kaiapoi.

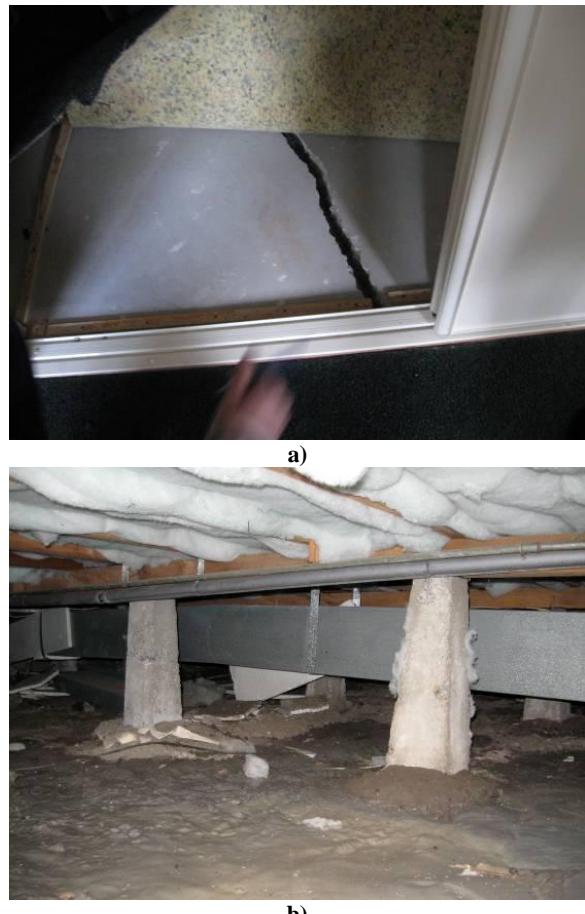
Several concrete floor slabs fractured due to uneven liquefaction induced settlements. This occurred mostly in modern buildings, some of which had little or no observable slab reinforcement. NZS3604 does not require any slab reinforcing (except in edge beams) for single storey houses. Structural damage may have been reduced if more reinforcing had been used in the slabs with better detailing, or if a thicker solid slab or thick ribbed slab (Ribraft) had been used.

Figure 2: Differential settlement of building due to liquefaction (a) cracking in ground floor slab (b) settlement of piles.

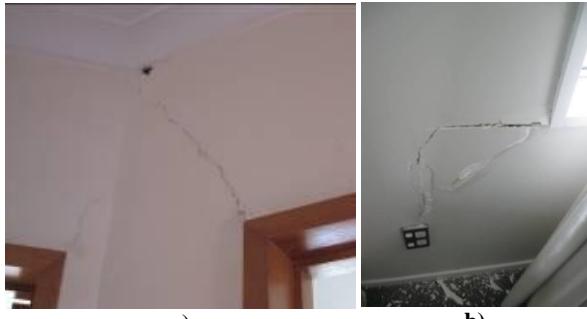
Compared with Christchurch city, slightly more damage occurred in areas with high proximity to the fault rupture, such as West Melton, where cracking to gypsum board linings and brick veneer was common (see Figure 3). The severity of shaking in West Melton caused some concrete slabs to move or crack.

Many houses in Christchurch had zero cracking to internal linings, and others had a few very minor cracks, usually near door or window openings. Due to the limited wall damage, it can be inferred that the gypsum board wall linings worked well to provide most of the bracing to the buildings. Some buildings had additional plywood bracing panels, but it is not possible to visually determine the location of these in an undamaged house. Larger movements and cracks in some older buildings showed that lath and plaster is not as stiff as modern gypsum board as a bracing material. Buildings with heavy roofs tended to have more lining damage than those with light roofs.

Figure 3: *Cracking of gypsum board linings.*

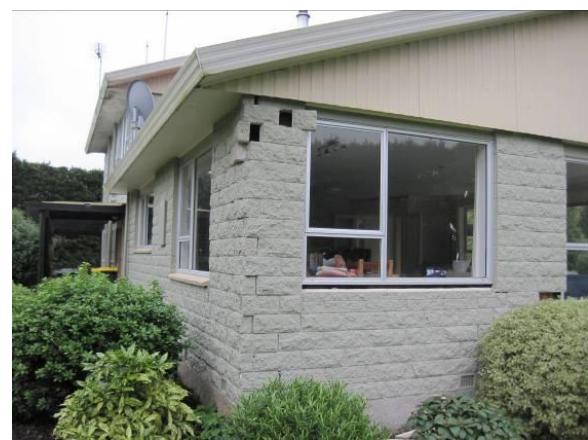
a)

The vast majority of unreinforced brick veneers suffered very little or no damage. Some had minor cracking in the mortar joints but no lateral displacement of the brickwork. In a small number of cases, mostly close to the epicentre, brick veneers became cracked or partially detached from the framing (see Figure 4). In one particular building (see Figure 5), recycled brick veneer performed very poorly because the bricks had not been properly cleaned, and there was no adhesion of the mortar, reducing mechanical interlock between the new mortar and the old bricks.

Figure 4: *Two examples of brick veneer cracking.*

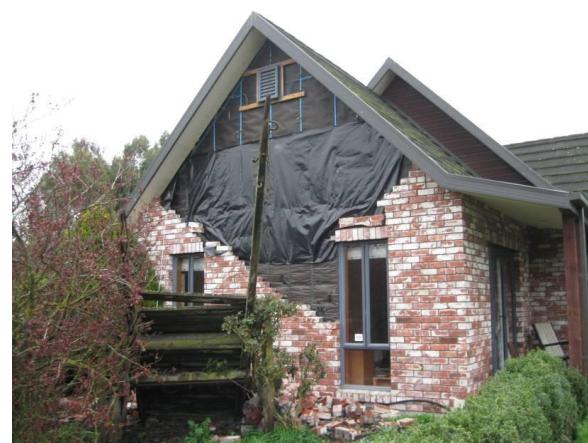
Figure 5: *Collapse of recycled brick veneer.*

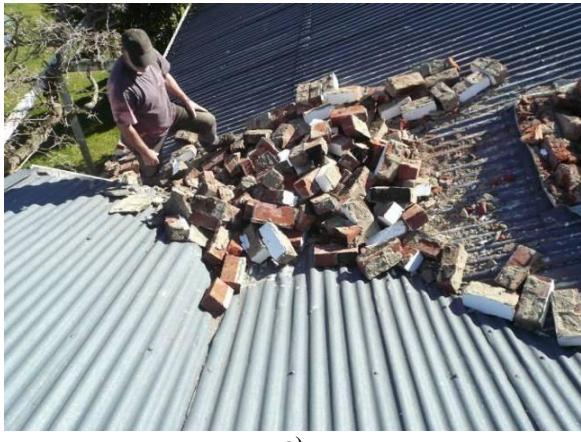
a)

The most common type of damage for older buildings (more than 15 years old) was chimney collapse. This occurred in many thousands of buildings (see Figure 6). Falling chimneys could be interpreted as a violation of the 'life-safety' criterion required by New Zealand Standards (NZS1170.5 2004) [2] for current building seismic design. Falling chimneys resulted in damage or piercing of the surrounding roof structure, damage to neighbouring properties, vehicles but (luckily) no loss of life.

Chimney collapse on to corrugated steel roofing often caused no further damage, depending on the height of the chimney, but some fell through the roof or caused rafter failure. Chimneys falling on to tile roofs (concrete or clay tiles, or slate roofs) more often fell through into the house, sometimes causing further structural damage and potential loss of life.

Figure 6: (a) Collapsed chimney on corrugated iron roof; (b) Damaged chimney being removed.

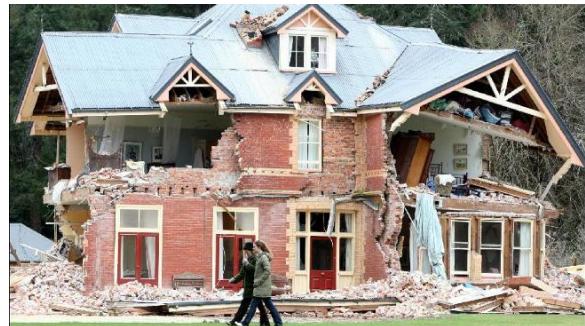
There was extensive damage and partial collapse of old (pre-1930) unreinforced brick masonry houses which do not comply with modern standards. The majority of these buildings consist of double brick structural walls and timber roof trusses, typical of early colonial construction. The Deans Homestead at Homebush is an example (see Figure 7). A number of unreinforced or minimally reinforced concrete block structures (garages and houses) suffered from partial collapse or had very large diagonal cracks. Performance of unreinforced structural masonry buildings is discussed in more detail elsewhere in this bulletin.

Figure 7: Collapse of double brick veneer house at Homebush (Lyndon Mechielsen, Source: *The Australian*).

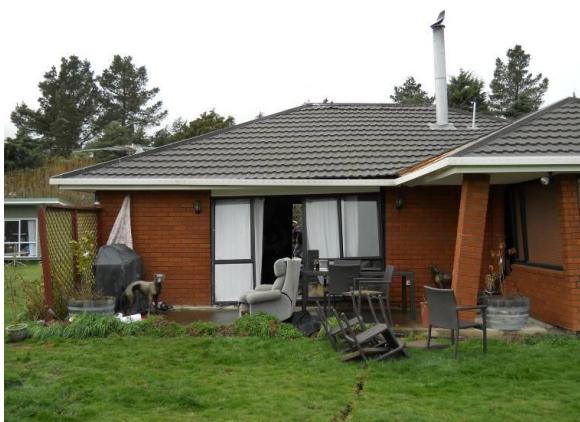
a)

There were limited cases of damage due to differential ground displacement under buildings located on the fault rupture. Concrete slabs and building envelopes were ruptured (see Figure 8). Damage was similar to that seen in buildings that suffered from heavy liquefaction and lateral spreading. The ceiling diaphragm and roof trusses held the structure together, avoiding collapse of the structure.

Figure 8: Damage due to fault rupture: (a) Fault rupture passing through house (c.o. G. A. MacRae) (b) Crack in floor slab of another house
