INANGAHUA EARTHQUAKE 1968

DAMAGE TO STATE HIGHWAYS

J. S. Douglas, A.M.I.C.E.*

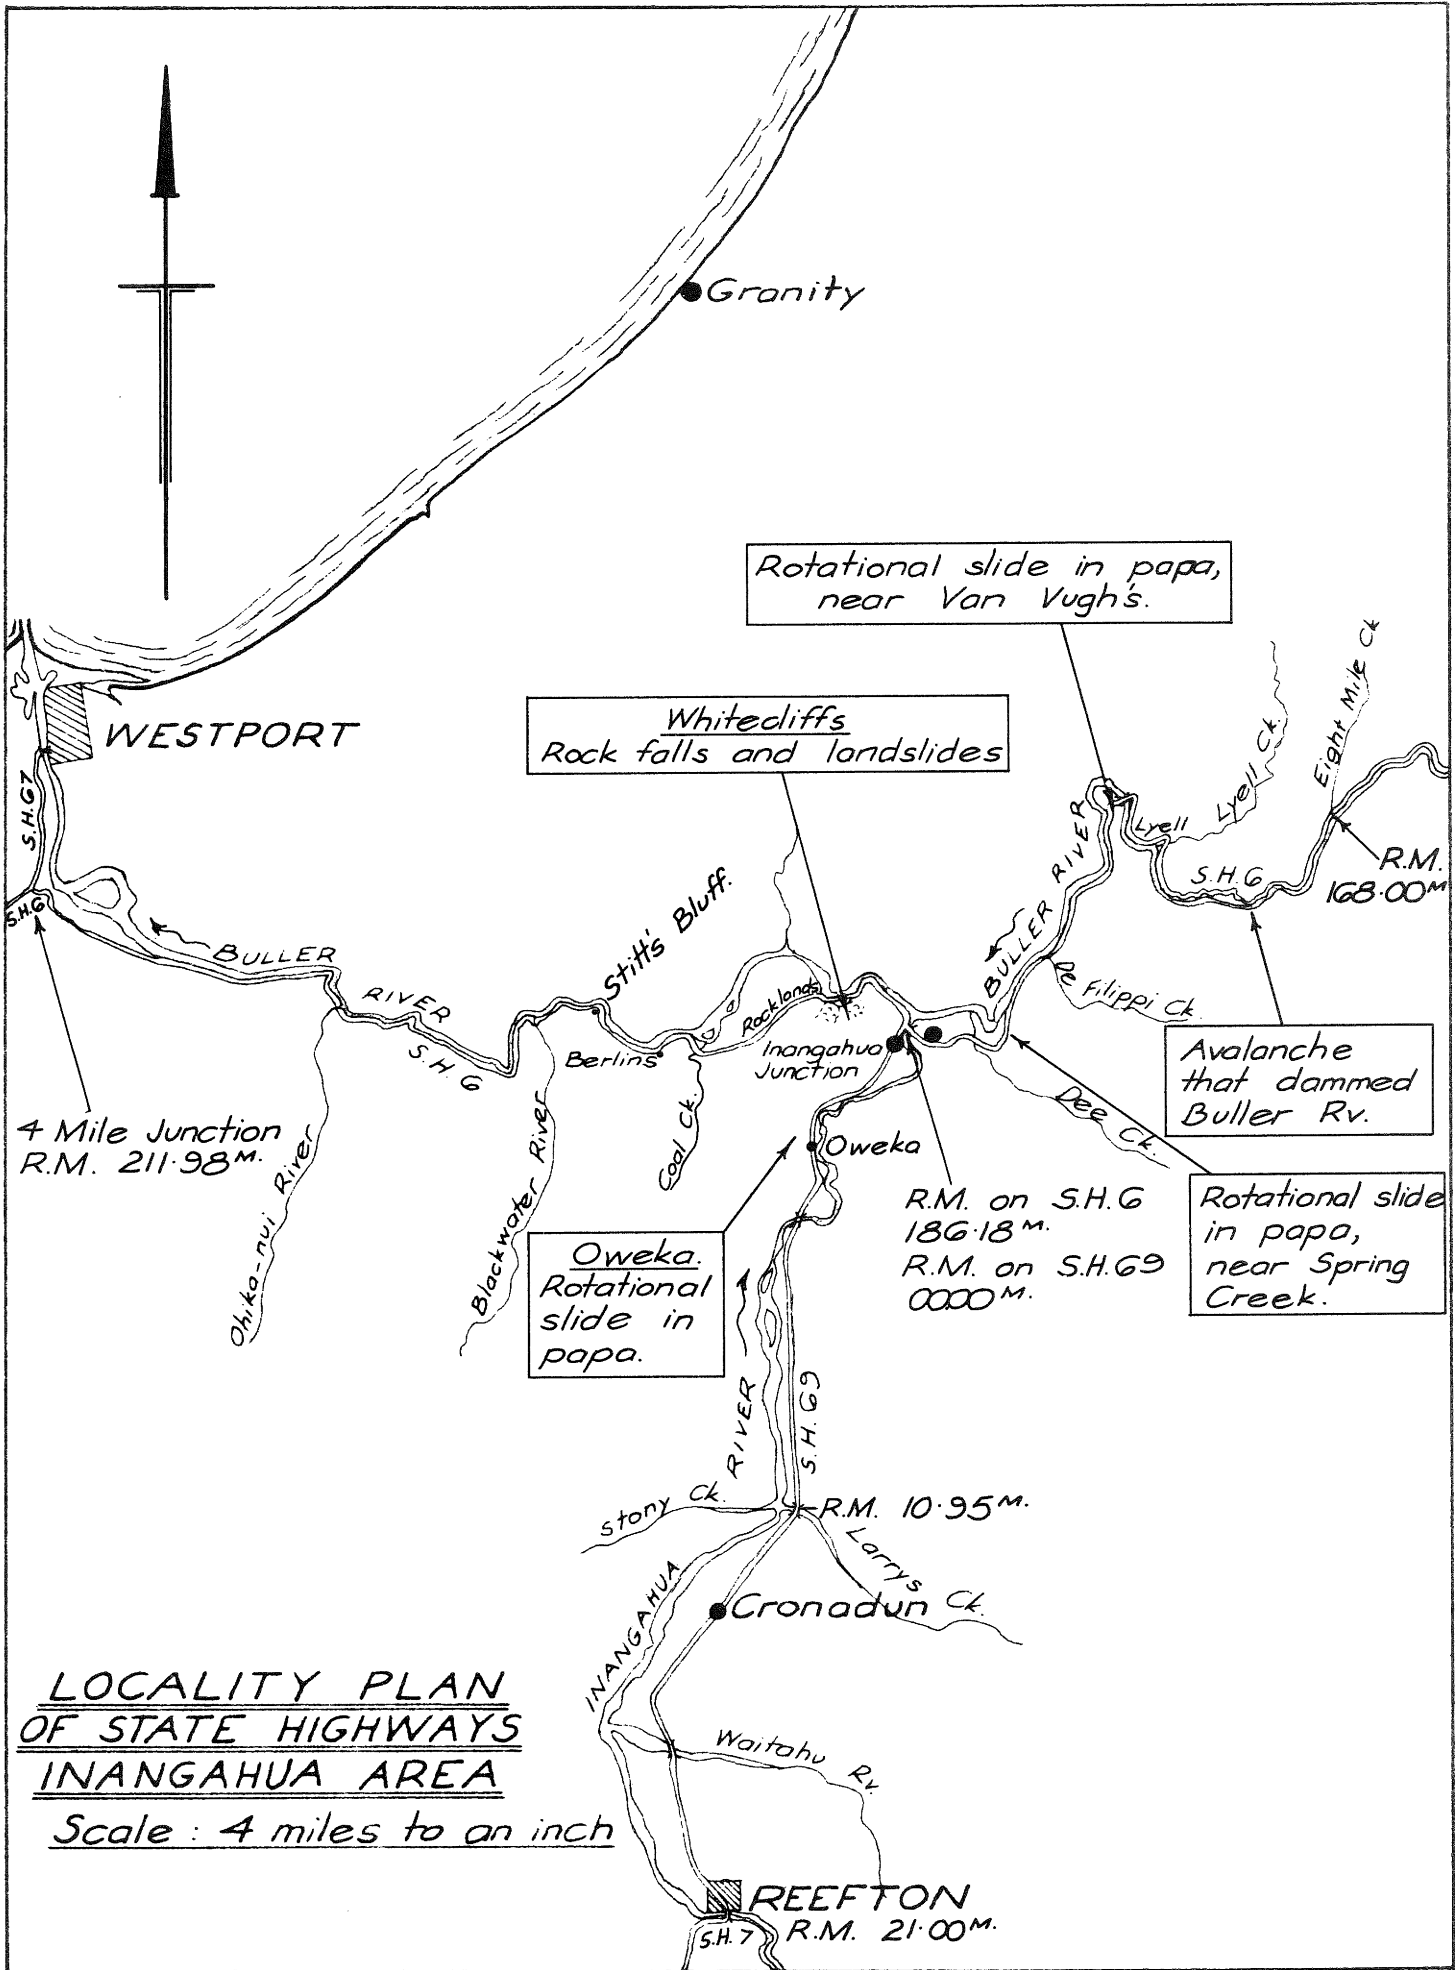
Rotational slide in papa, near Van Vugh's.

Whitediffs
Rock falls and landslides

Avalanche that dammed Buller Rv.

Rotational slide in papa, near Spring Creek.

Oweka.
Rotational slide in papa.
