# THE MODIFIED MERCALLI EARTHQUAKE INTENSITY SCALE – REVISIONS ARISING FROM RECENT STUDIES OF NEW ZEALAND EARTHQUAKES

D. J. Dowrick<sup>1</sup>

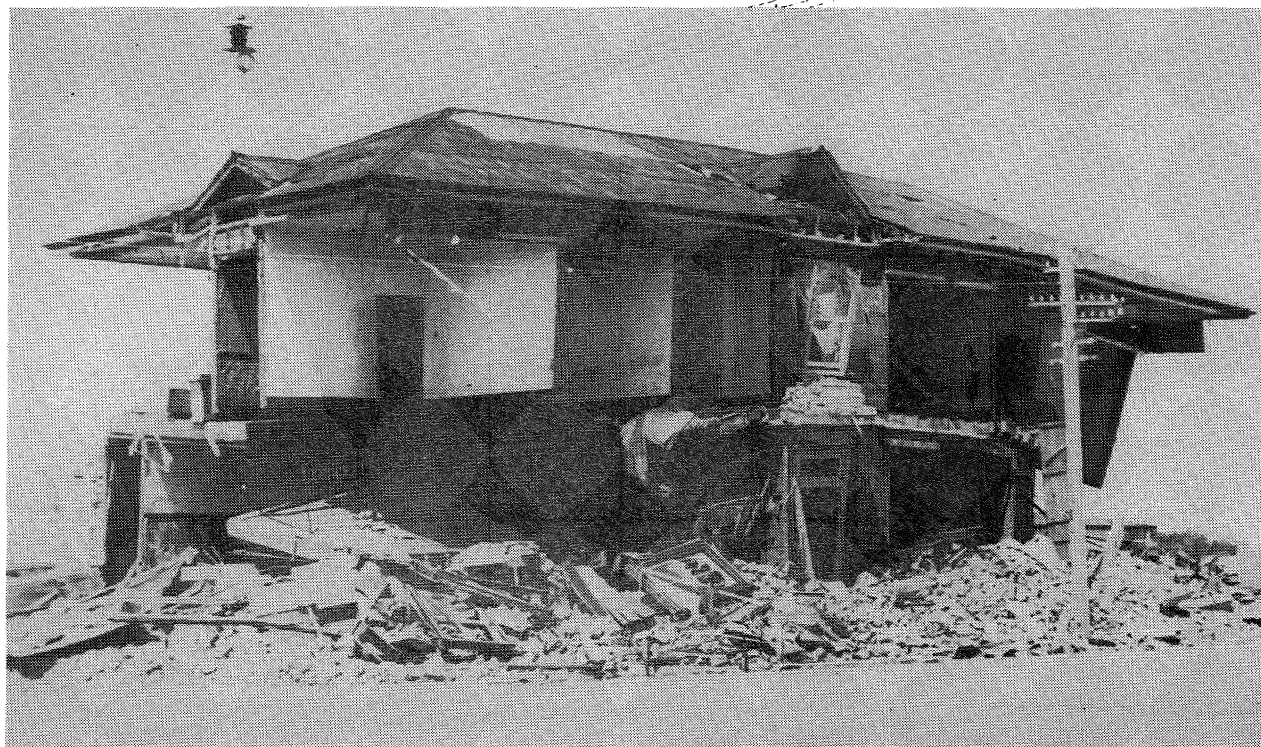
**FIGURE 1(A)** Examples of Partial Collapse: Taradale Hotel in the 1931 Hawke's Bay earthquake, arguably small volume loss despite collapse of external brick walls, deemed not repairable. (Reproduced by courtesy of the Alexander Turnbull Library, Wellington).

*Partial collapse*: means that part of the building collapses, and a substantial remnant still stands. The volume of the collapsed part is likely to be less than about 30% of the total volume. At minimal partial collapse, virtually no volume (internal void) loss may be involved, i.e. walls may fall but not floors or roof (Figure 1a). A wall falling may be initiated by a parapet or gable falling, which peels off the wall below. Partially collapsed structures may or may not be repairable, depending on which portion has collapsed and on the integrity of the surviving portion. A non-repairable partially collapsed building (e.g. a ground floor soft storey collapse, Figure 1(b)) is better described as "destroyed" (see below).

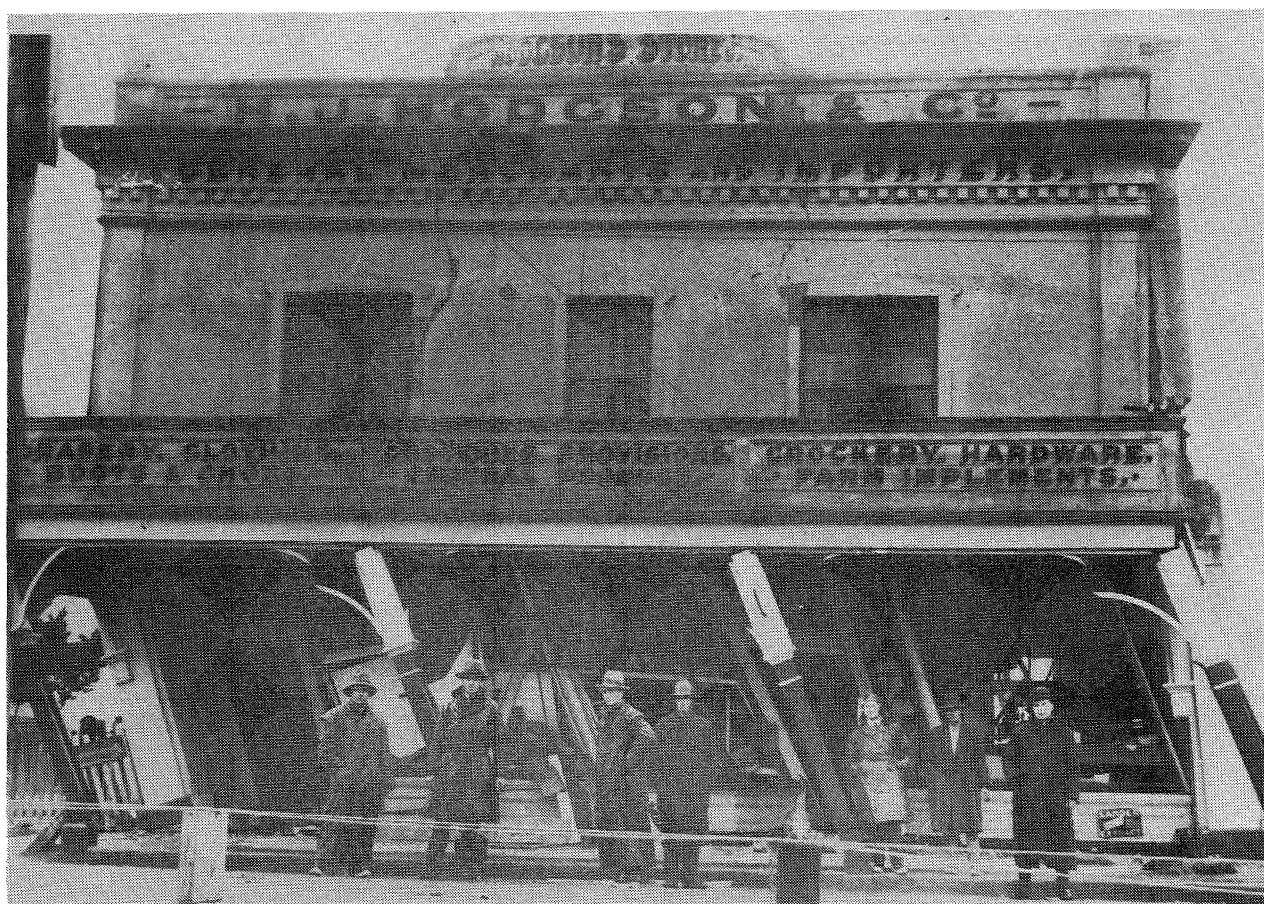
**FIGURE 1(B)** Example of Partial Collapse: Hodgson's Store, Murchison, in the 1929 Murchison earthquake, small volume loss, not repairable. (Reproduced by courtesy of the Alexander Turnbull Library, Wellington).

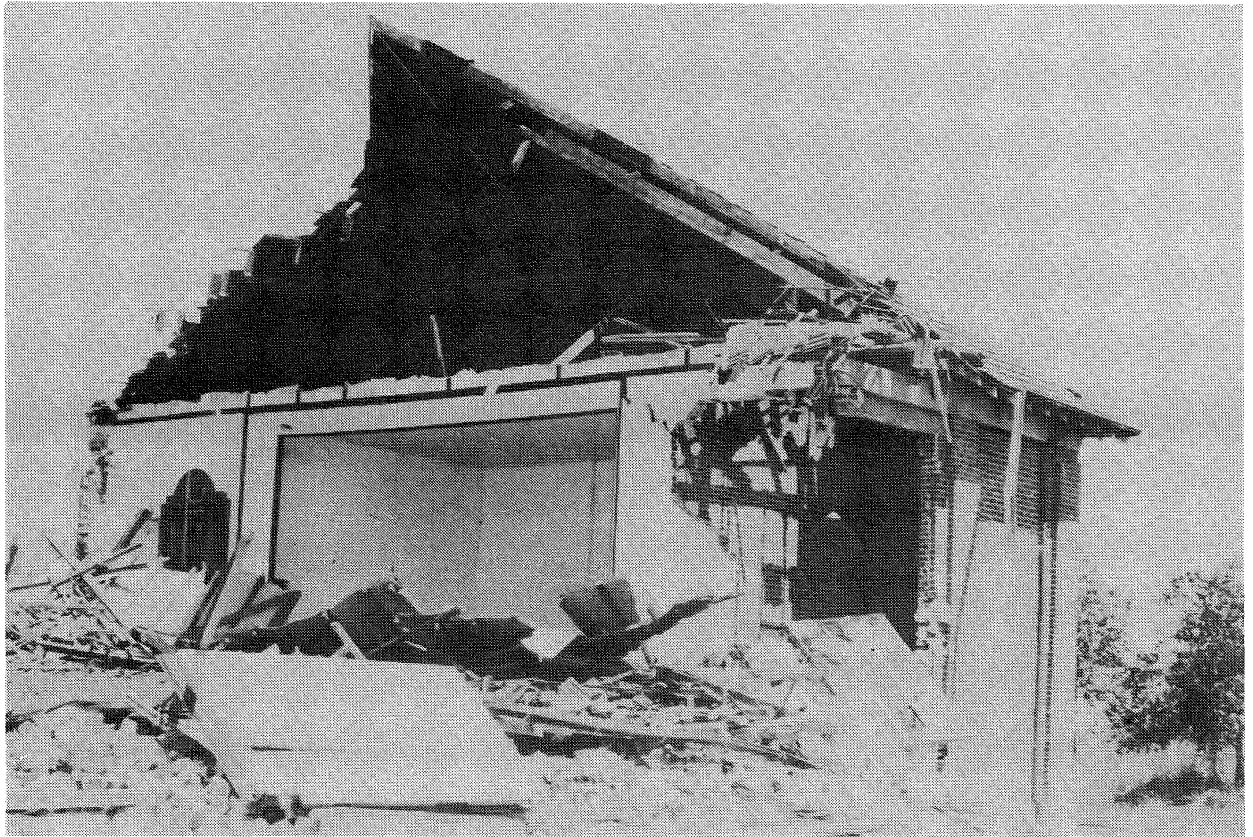
**FIGURE 2(A)** *Example of Collapsed building: Napier Boys High School Assembly Hall in the 1931 Hawke's Bay earthquake, more than 50% volume loss. (Reproduced by courtesy of the Auckland University Architecture Library).*

*Collapse*: "Collapse" is worse than "partial collapse", implying that the building is not repairable. The loss of internal void volume is likely to be greater than 50%, such as illustrated in Figure 2(a). (The term "complete collapse" is also sometimes used by engineers, though not in the MM scale; this implies a 90% or more loss of internal volume (Figures 2(b)), but such a severe definition for "collapse" is unnecessarily restrictive.)

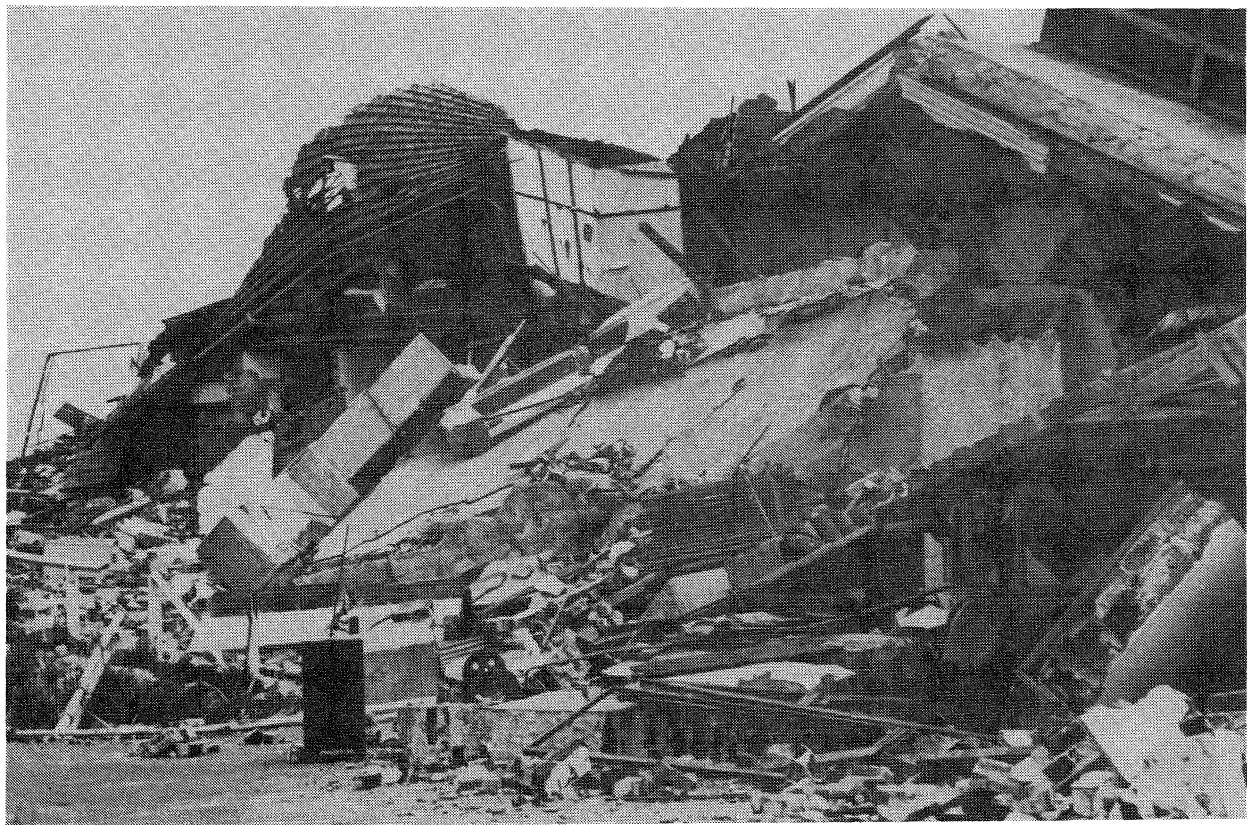
**FIGURE 2 (B)** *Example of Collapsed building: Nurse's Home, Napier Hospital, in the 1931 Hawke's Bay earthquake, 100% volume loss. (Reproduced by courtesy of the Auckland University Architecture Library).*

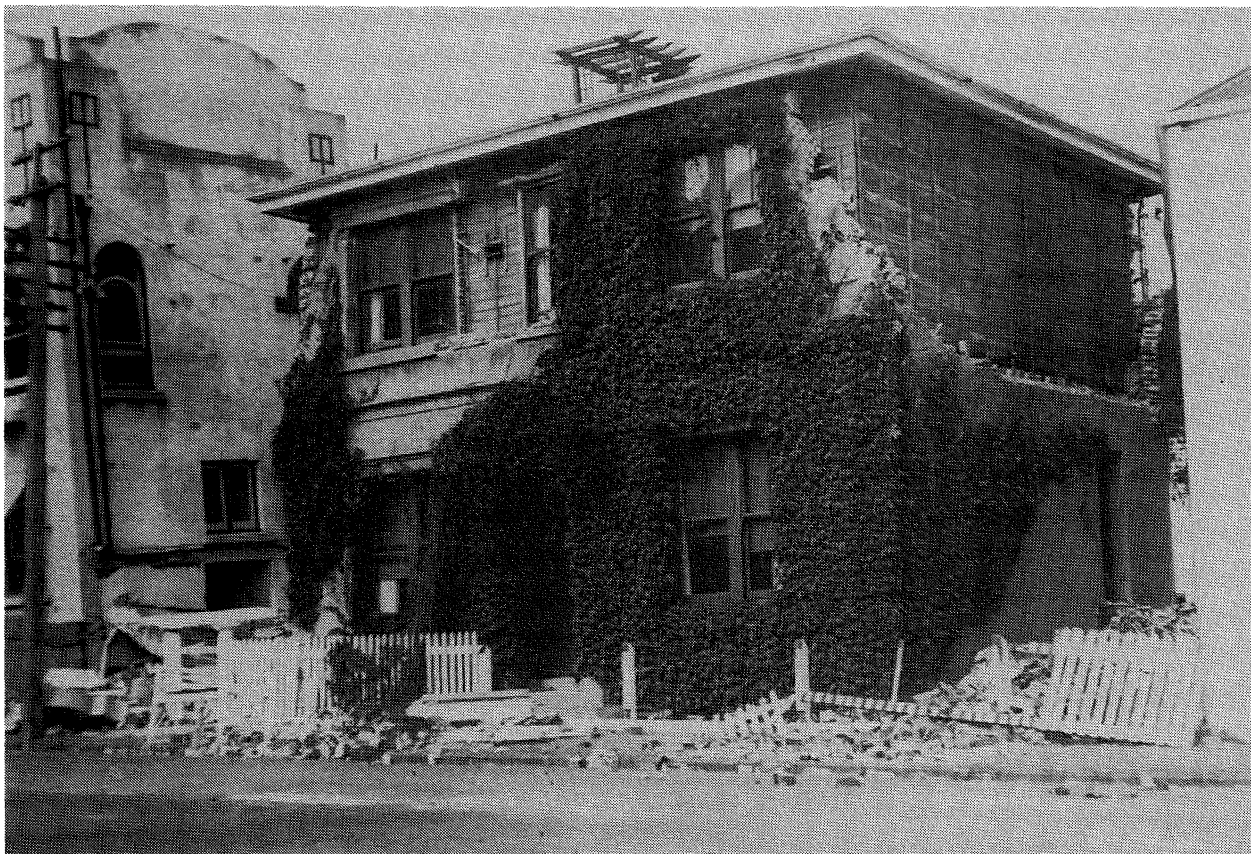
**FIGURE 3(C)** *Example of supposedly Destroyed building: Hawke's Bay Club caretaker's residence, Napier, in the 1931 Hawke's Bay earthquake, stated to be beyond repair (through cracking), but strengthened and still in use in 1996. (Reproduced by courtesy of the Alexander Turnbull Library, Wellington).*

*Destroyed*: means "beyond repair". This includes not only collapsed buildings, but also others so heavily weakened or deformed, that it would probably be better/cheaper to rebuild than to repair them (Figures 3(a) and 3(b)). (Collapses are easy to judge, but "beyond repair" often needs time to elapse for true assessment to occur. For example many buildings in Napier in 1931 were initially assessed as beyond repair, but were repaired later (Figure 3(c)); and vice versa (Figures 4(a) and 4(b)).

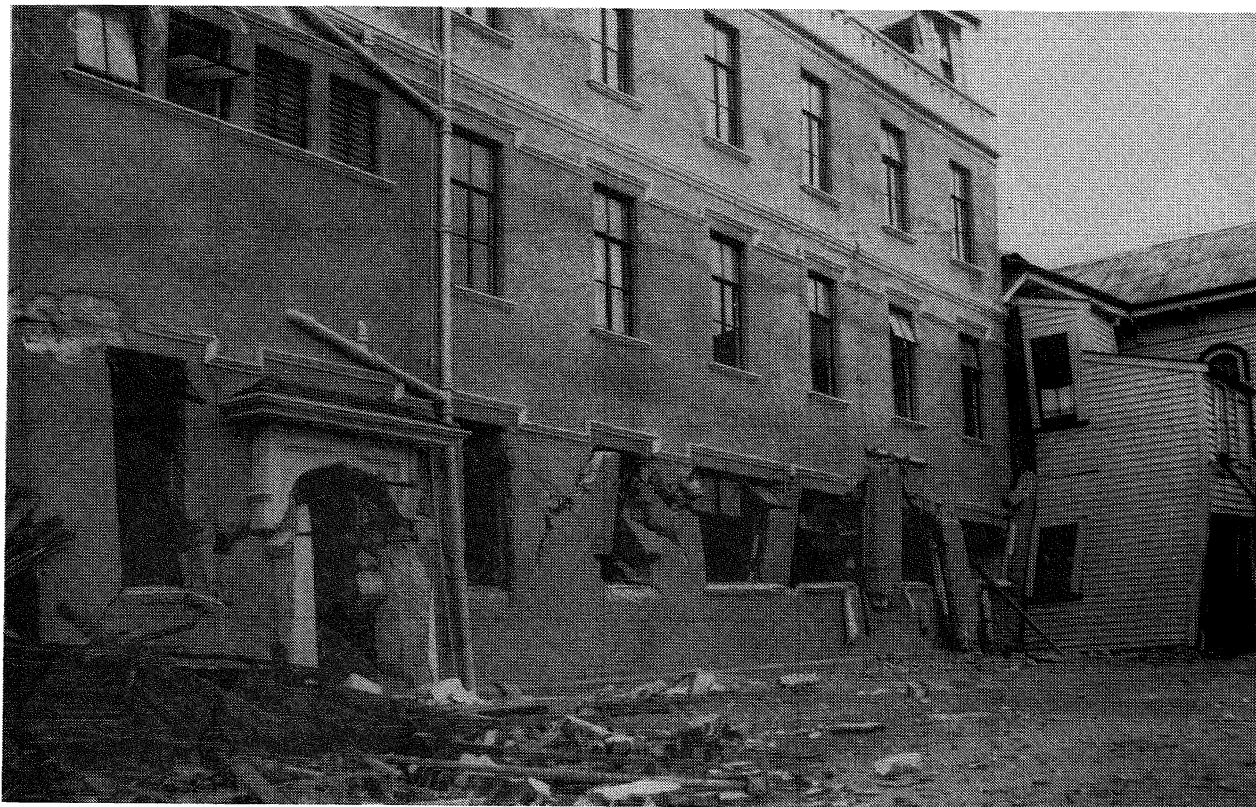
**FIGURE 4(A)** *Examples of Partial Collapse: Seminary at Greenmeadows in the 1931 Hawke's Bay earthquake, small volume loss, stated to be beyond repair, though means of repair were examined. (Reproduced by courtesy of the Alexander Turnbull Library, Wellington).*

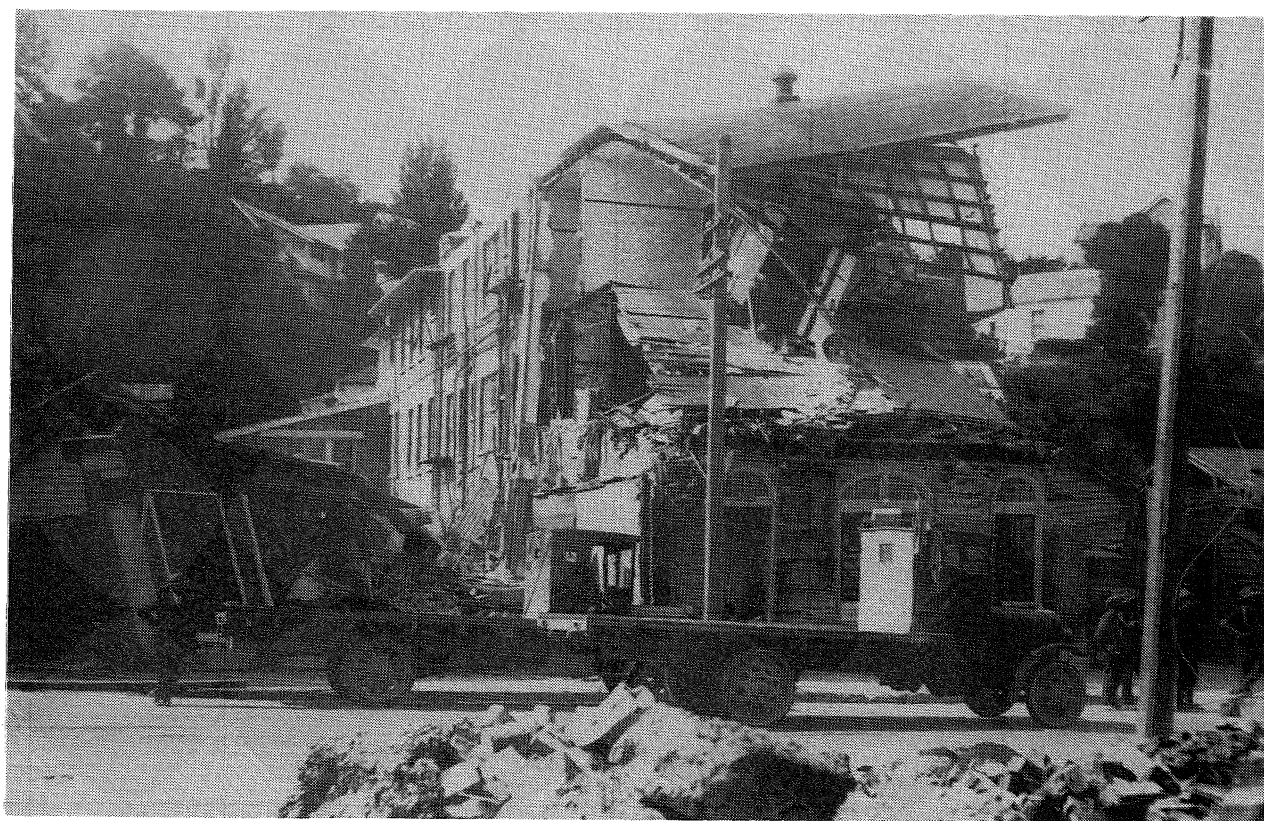
**FIGURE 4(B)** *Example of Partial Collapse: Empire Hotel, Napier, in the 1931 Hawke's Bay earthquake, about 25% volume loss, stated to be beyond repair, but collapsed portion rebuilt. (Reproduced by courtesy of the Alexander Turnbull Library, Wellington).*
